Re: Visual Site Inspection
Van Waters and Rogers, Inc.
Bedford Heights, Ohio
OHD 071 107 791

**PRELIMINARY ASSESSMENT/
VISUAL SITE INSPECTION**

VAN WATERS & ROGERS, INC.

RELEASED BEDFORD HEIGHTS, OHIO
DATE 11/01/01 OHD 071 107 791
RIN #
INITIALS sk **FINAL REPORT**

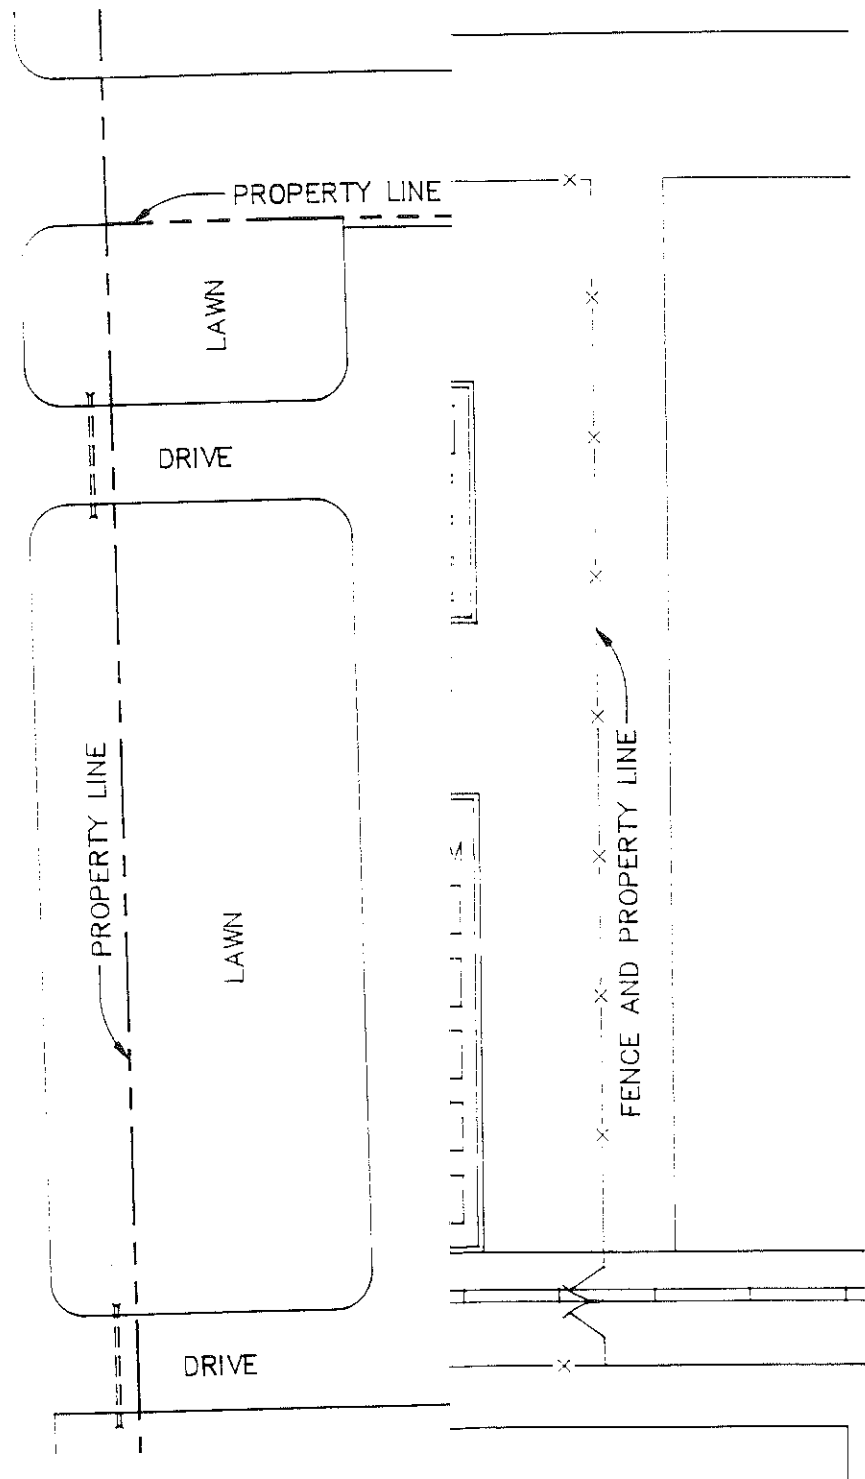
FIGURE 2
FACILITY LAYOUT

The facility's SWMUs are identified in Table 1. The facility layout, including SWMUs, is shown in Figure 2. The facility's waste streams are summarized in Table 2.

CORROSIVE PRODUCT	
TANK NUMBER	PRODUCT
1	AMMONIA
2	HYDROCHLOR
3	SULFURIC AC
4	NITRIC ACID
5	HYDROGEN F

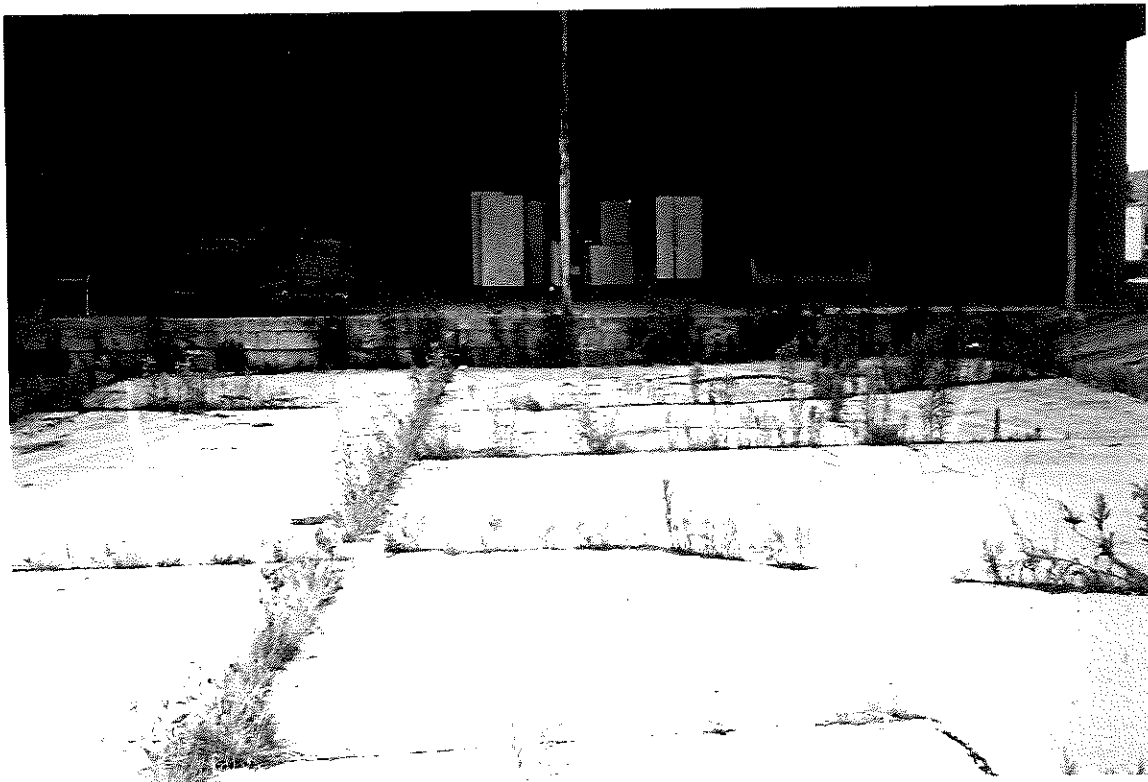
Photograph No. 1

Observations: This unit was inactive at the time of the VSI. PRC noted several large cracks in the unit's concrete pad and locations of boreholes associated with closure sampling activities. The concrete area was sloped slightly downward to the northwest. No evidence of release was noted (see Photograph No. 1).

Description: Hazardous Waste Container Storage Area (CSA), is designated as the area between the yellow X's painted on the concrete

Location: SWMU 1

- CSA - concrete area - not
burned - run-off water
to go in all directions
- several cracks in the concrete
- sloped slightly north
- area is marked with yellow
paint

Recommendations: PRC recommends closure activities continue as scheduled to address any contamination from past releases that may have occurred. As part of closure activities, additional soil sampling at areas surrounding the unit may be required.

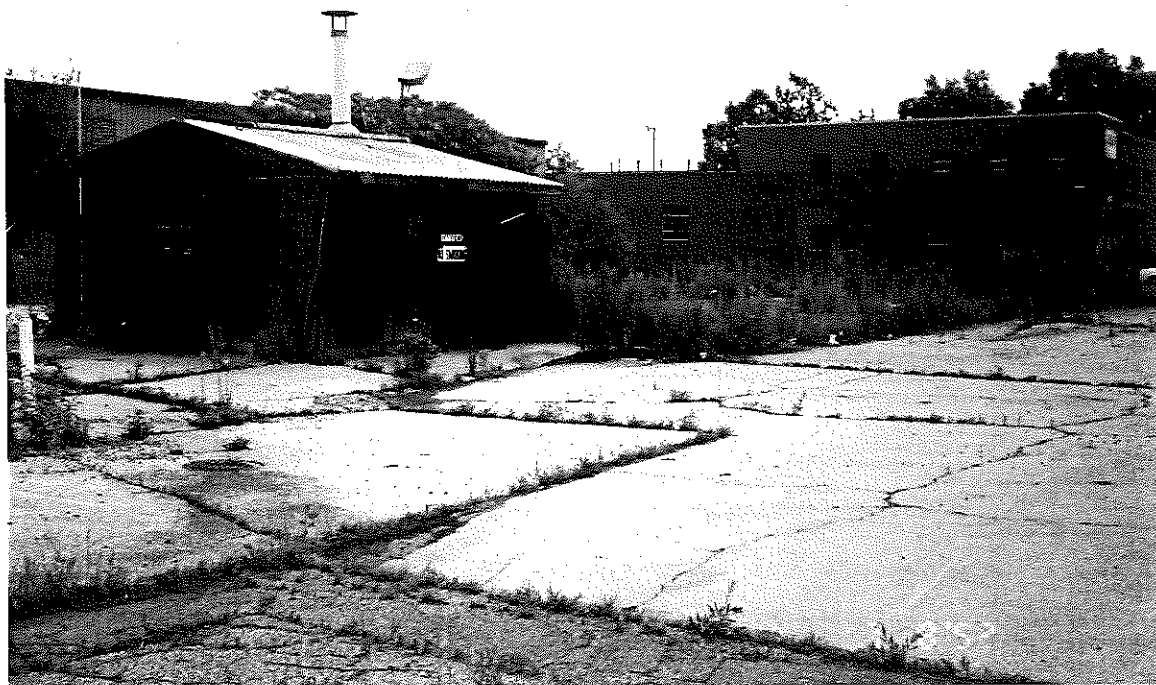
Photograph No. 2

As McKesson had done previously, VW&R operated the facility as a chemical warehouse and distribution center, and temporary hazardous waste storage facility. About 25 people were employed at the facility. The facility's masonry, steel-framed main building has an area of about 20,500 square feet. About 2,700 square feet of the building was used for office space. The remaining 17,800 square feet was used as a warehouse to store raw chemicals in containers. Raw chemicals were also stored in bulk in one of two tank farms: (1) the corrosive tank farm and (2) the solvent tank farm (see Photograph Nos. 2 and 3).

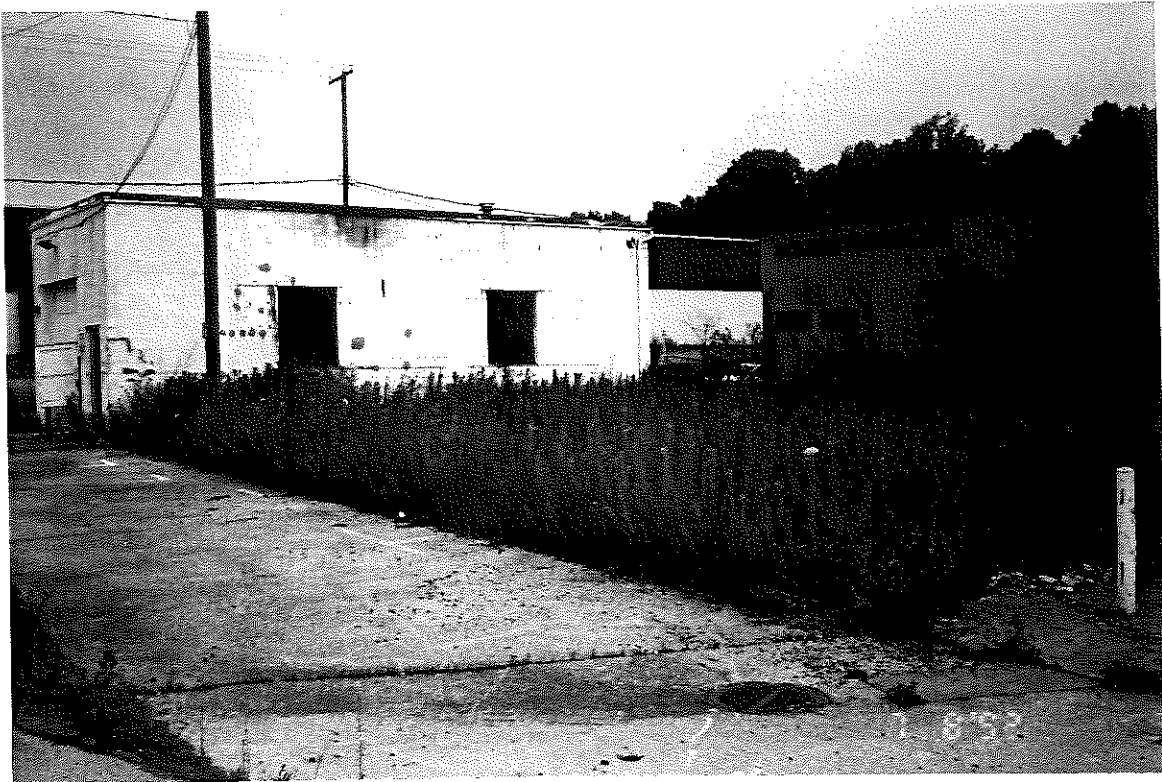
Photograph No. 3

PRC observed that this unit had been removed, and the area was filled with gravel. Vegetation was growing within this gravel area. No evidence of release was noted (see Photograph No. 3).

Description: Corrosive Repack Building (left) and former location of the Elementary
Neutralization Unit (SWMU 2) and caustic tank farm

Recommendations: PRC recommends no further action at this time.
